**Coal Combustion Residue Impoundment  
Round 9 - Dam Assessment Report**

*Plant Kraft*  
*CCR Impoundment Ash Dikes*  
*Georgia Power*  
**Port Wentworth, Georgia**

Dewberry & Davis, LLC  
Fairfax, Virginia

Under Contract Number: EP-09W001727  
**December 2011**

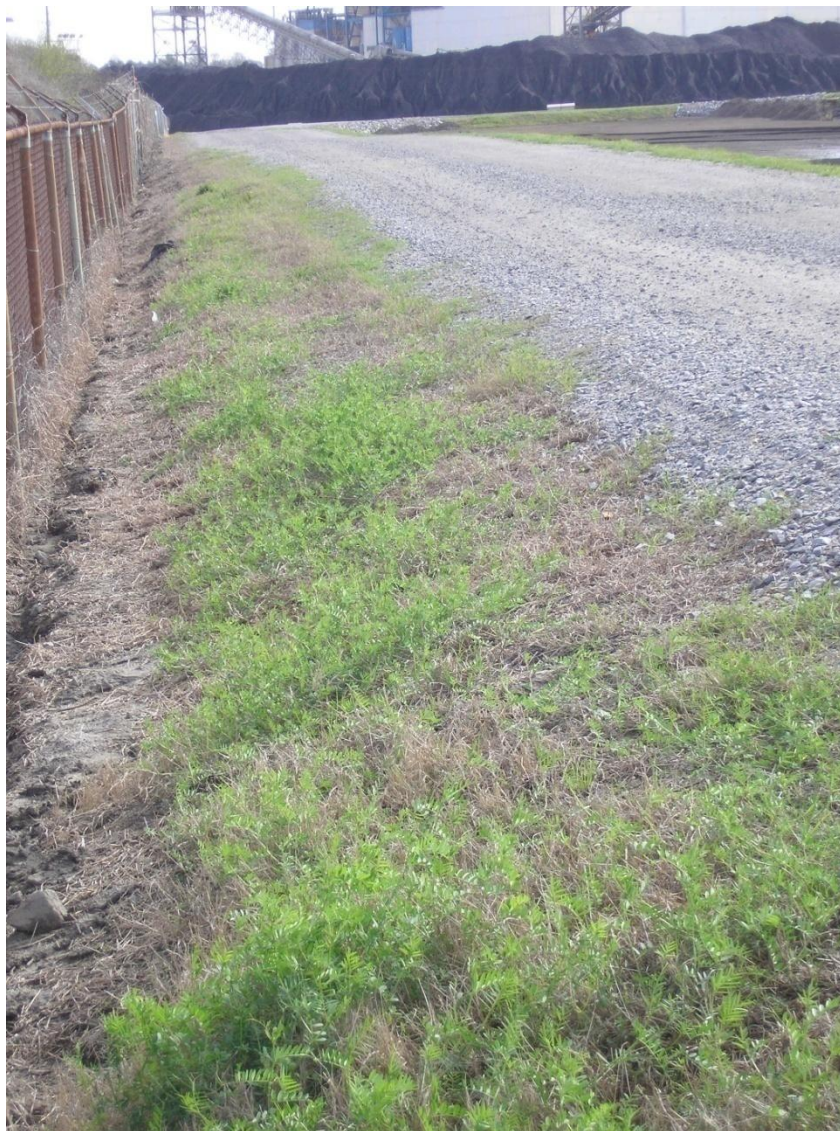
Figure 5.2.3-1 Outside Slope of Embankment on North Side of Impoundment

Figures 5.2.3-1 and 5.2.3-2 show the outside slopes of the embankment on the north and south sides of the impoundment, respectively.

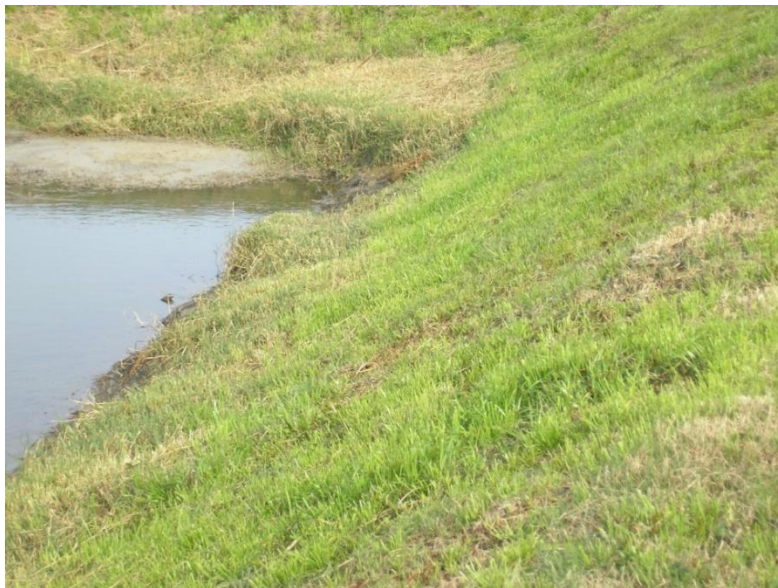
Figure 5.2.4-2: Groin Area Southeast Corner of Embankment

Erosion or uncontrolled seepage was not observed along embankment groins. Embankment groins on the north side of the CCR impoundment have had riprap added to protect against erosion caused by surface runoff across the embankment crest.

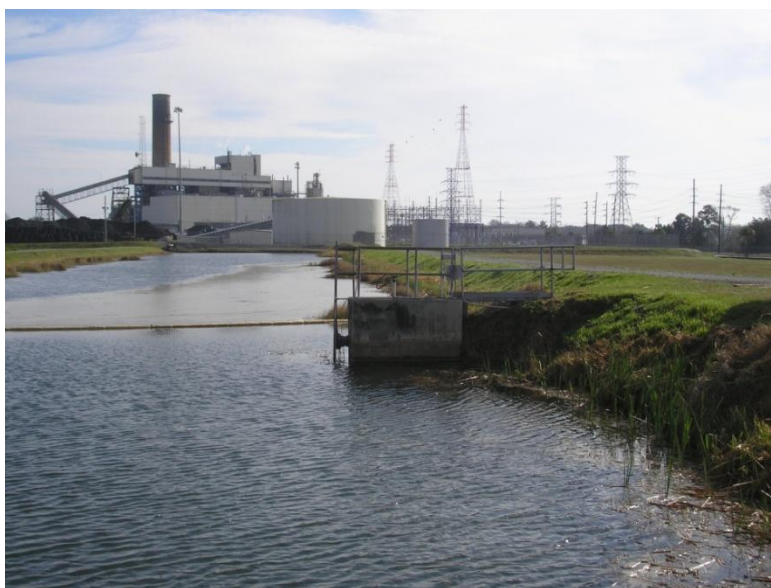
Figure 5.3.1-1 Outlet Structure

The impoundment overflow structure is located in the southwestern corner of the impoundment. The overflow structure consists of a concrete riser in which flow is controlled by a weir and stop logs. Figure 5.3.1-1 shows the riser structure.

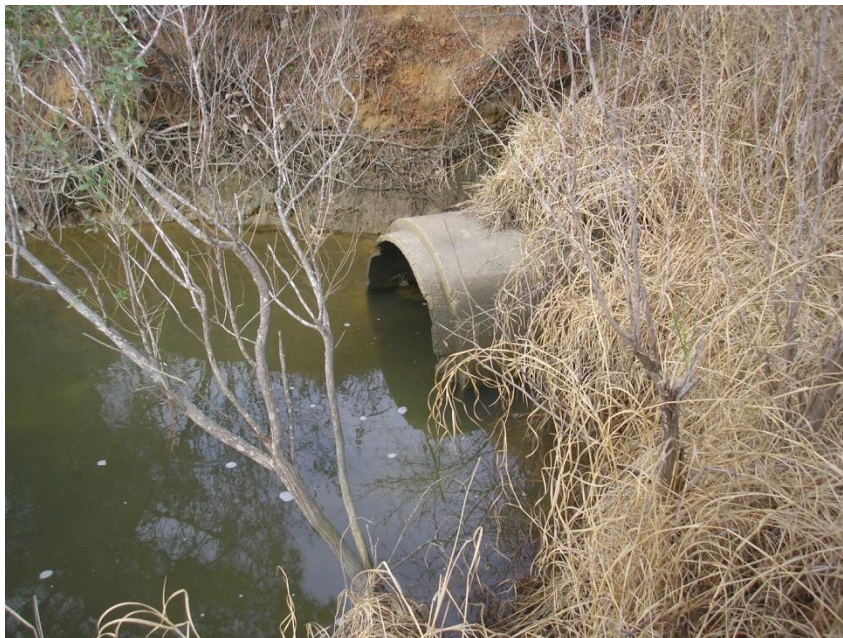
Figure 5.3.2-1 Outlet Conduit Discharge Location

The outlet conduit consists of a 42-inch diameter concrete pipe that discharges to a drainage canal south of the CCR impoundment. The canal flows along the Plant Kraft property line to the Savannah River. At the time of Dewberry's site visit the water level in the drainage canal was above the bottom of the outlet conduit. Figure 5.3.2-1 shows the outlet conduit.

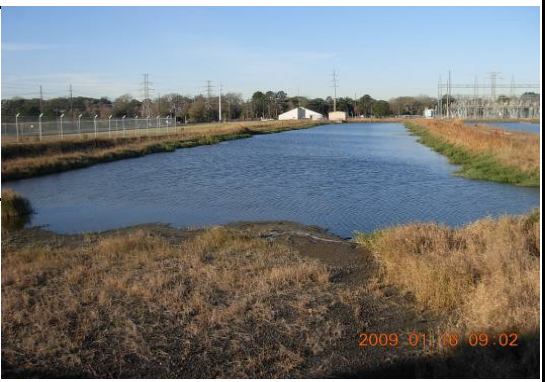
285 2833	Looking at southernmost cell from east end (looking west) There is a lot of bare soil in this area. It would be a good idea to get some grass growing on this slope and to put some gravel on the crest here.

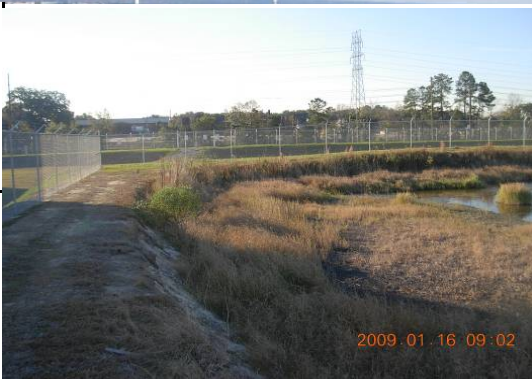
Location No. Photo No.	Description	Photo
285 2834	(looking south) West dike of southernmost ash cell. Slopes need to be grassed and crest needs to be grassed or graveled.

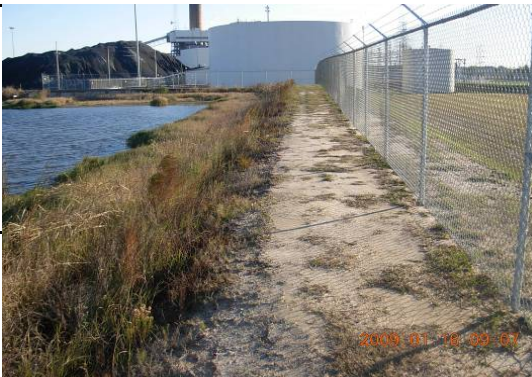
a. Condition	<i>The crest of the ash pond dike and the oil containment dike is bare in many areas. This appears to be due in some areas to four-wheeler traffic. It would be a good idea to either discontinue this traffic and grass the crest or, if the traffic is to continue, to gravel the crest.</i>	<b>286-2835 286-2836</b>
--------------	--	------------------------------

286 2835	South dike (looking east) The crest of the dike needs to be graveled or grassed. The bare spots appear to be the result of four-wheeler traffic. In that case, it would be better to gravel the crest.

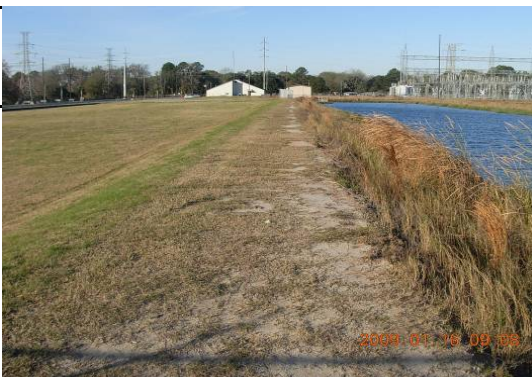
286 2836	South dike (looking west) Crest needs grassing.

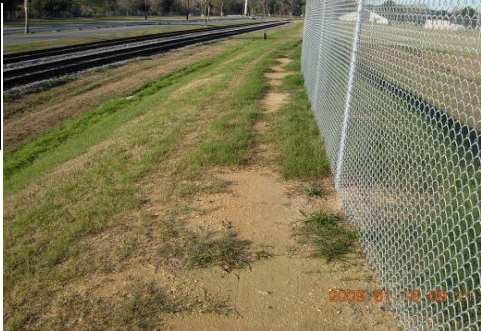
288 2837	Oil tank containment berm (looking west) Loss of grass, probably due to four-wheeler traffic. The crest needs grassing or gravel.

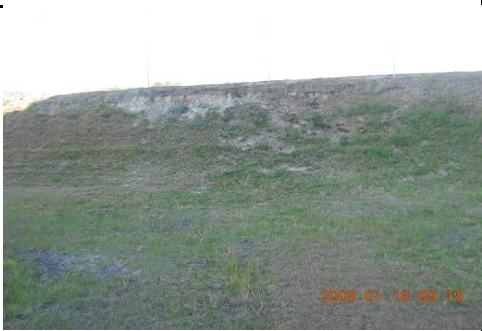
290 2840	This segment of the outside of the containment dike is way too steep. This is contributing to the erosion. The best way to fix this would be to import some soil and flatten the slope. Barring that, the next best thing to do would be to mulch, seed, fertilize the slope, then mow it carefully with weed eaters.

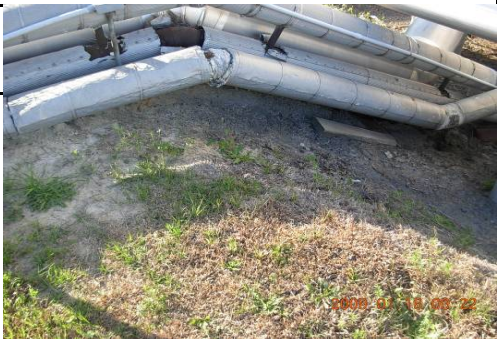
291 2841	Minor erosion on inside of oil containment dike. This area could use some gravel.

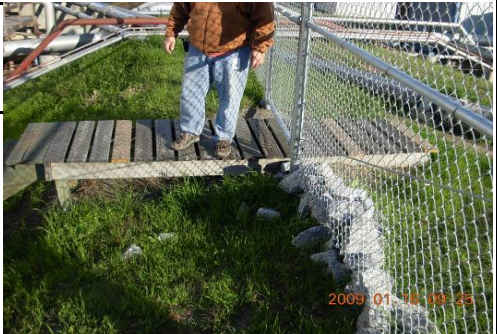
292 2842	This may be a low spot on the dike rim. It would be a good idea to shoot this with a level to see if it is.

4	Oil containment: There is a spot on the rim of the containment that appears to be lower than the remainder of the rim. This should be checked with a level to see if it is lower or not, and if there is a particular reason that it is lower.	292-2842
5	Ash Monofill: The whole site could use a general application of fertilizer to invigorate the grass cover.	296-2856 299-2859 300-2860 302-2864
6	Ash Monofill: There are a number of scalped and rutted places on the monofill that are the direct result of mowing activity. The mowing techniques and equipment should be changed to prevent this damage from recurring. This mowing damage will result in higher maintenance costs at best and may result in erosion of the earth cap and release of ash at the worst.	294-2854 300-2860 304-2867

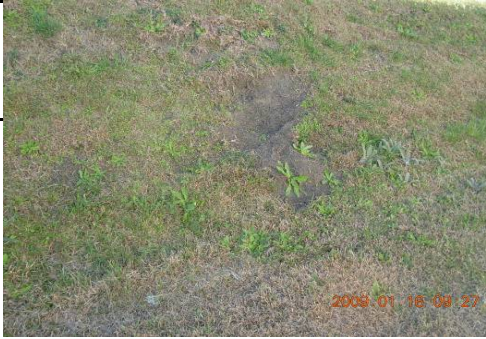
<b><u>Plant Kraft</u></b> <b>Oil Containment Dike Inspection Photographs - January 16, 2009</b> (See accompanying report attached)		
<b>Location No. Photo No.</b>	<b>Description</b>	<b>Photo</b>
<b>293 2843</b>	Mower gouges on slope.

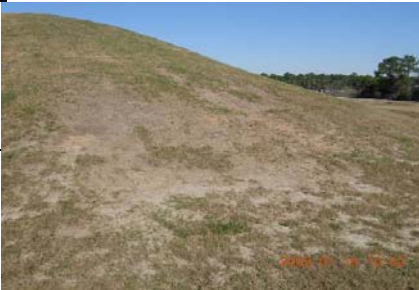
Location No. Photo No.	Description	Photo
294 2854	Bare patch on slope. Areas like this need to be seeded and mulched. The whole monofill could use a general application of fertilizer to strengthen the grass cover as well as special attention to bare spots like this one.

<b>7</b>	Ash Monofill: The bare spots on the monofill should be treated with seed, fertilizer and mulch to replace the grass cover.	<b>294-2854 297-2857 298-2858 304-2867</b>
<b>8</b>	Ash Monofill: The slide on the south side of the detention pond should be monitored to see if it moves any more	<b>306-2870</b>
<b>9</b>	Ash monofill: A splash pad should be constructed at the outlet for the plastic down drain pipe at location 301.	<b>301-2862 301-2863</b>
<b>10</b>	The oversteep slopes and ditches at locations 295, 301 and other locations should be flattened to a 3:1 or flatter slope, then grassed.	<b>295-2855 301-2862</b>

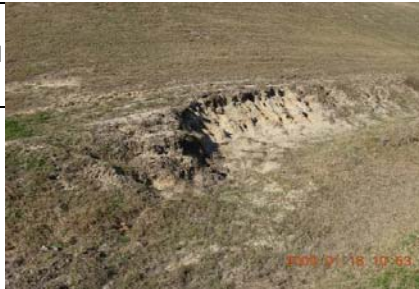
295 2855	Erosion of oversteep slope. This area should be graded to a flatter slope then seeded, fertilized and mulched.

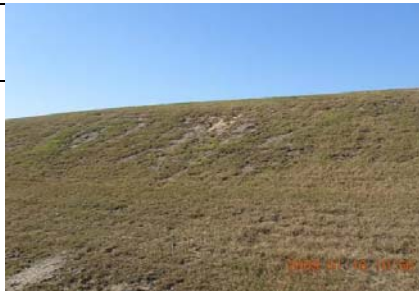
296 2856	Bare patches on slope.

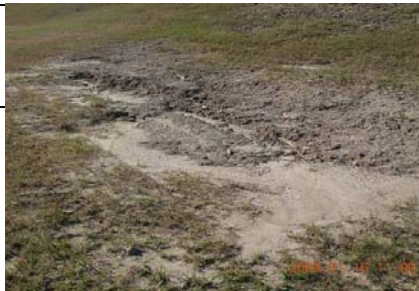
297 2857	Bare spot that has started to erode.

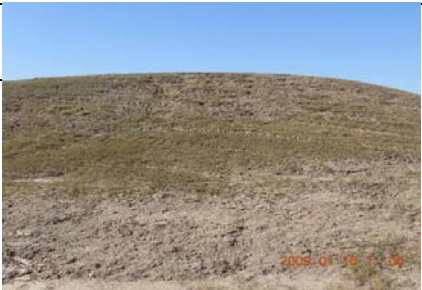
<p><b><u>Plant Kraft</u></b></p> <p><b>Grumman Road Ash Monofill Inspection Photographs</b></p> <p><b>January 16, 2009</b></p> <p>(See accompanying report attached)</p>		
Location No. Photo No.	Description	Photo
298 2858	Bare spot in foreground and thin grass on the slope in the background.

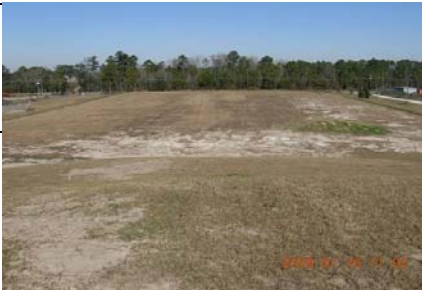
299 2859	View of northern cell from top of southern cell. Note thin grass cover in some areas.

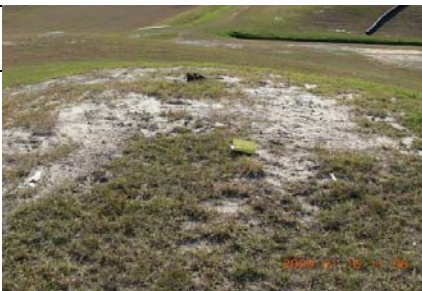
300 2860	Bare patches on crest of cell.

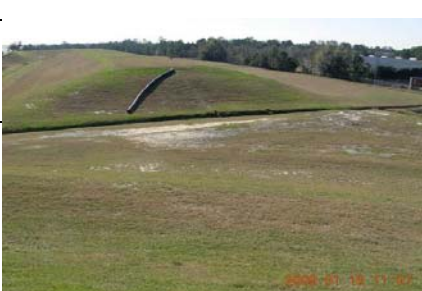
300 2861	View looking south from crest of northern cell toward southern cell. Note displaced black plastic down drain.

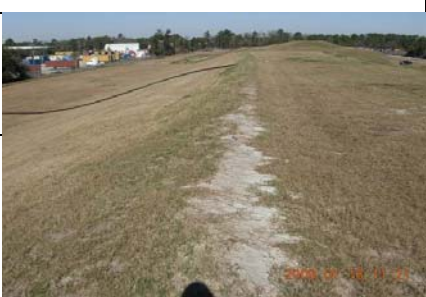
A wide-angle photograph showing a large, flat, grassy area (the south cell) from a distance (the north cell). The area is mostly green with some brown patches. A timestamp "2009-01-16 11:13" is visible in the bottom right corner.
304 2867	Damage to berm on top of landfill due to mower scalping. This could lead to serious erosion problems if not corrected.

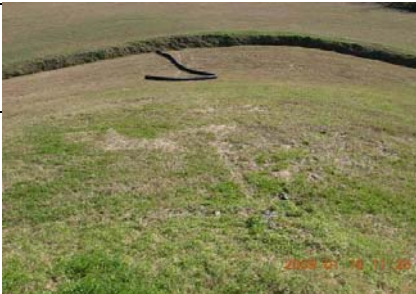
Location No. Photo No.	Description	Photo
305 2869	Displaced black plastic down drain. Probably moved by mowing crew.

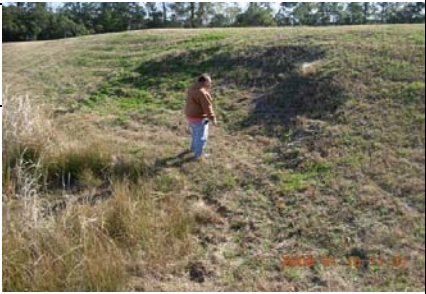
306 2870	Slide on south bank of detention pond. Large compliance specialist inserted for scale.

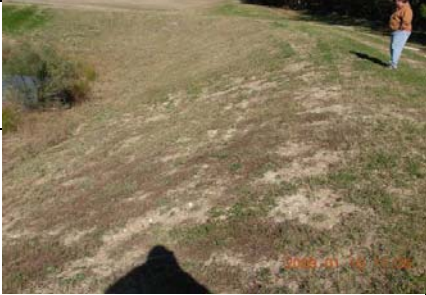
307 2871	East side of detention pond. Vegetation growing through outlet structure has been removed since the inspection. There are some bare spots on the pond slope.

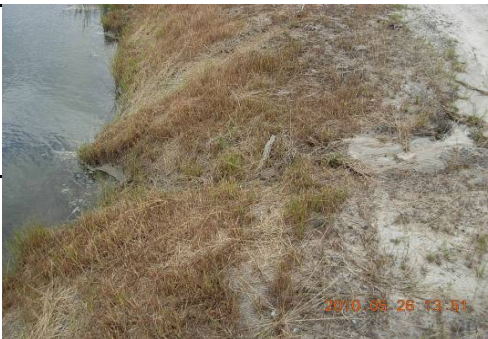
3906	Erosion under matting where concentrated storm flow from the crest road enters the pond. <b>This location can be improved with a plastic down drain and earth berm.</b>

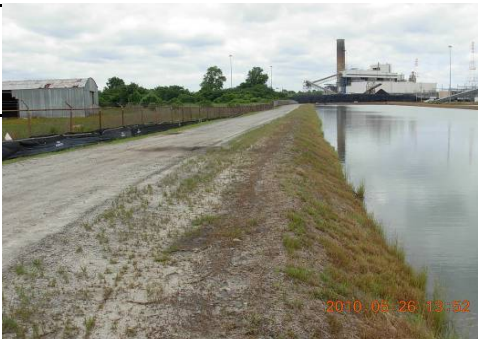
3907	North dike showing fair grass cover on upstream slope.

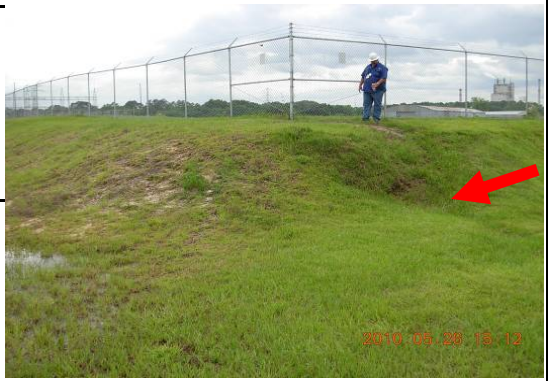
Photo No.	Description	Photo
3918	The slope to the right is very steep, making it very difficult to care for. This slope should be flattened with fill. The bare areas to the left will need treatment with seed and fertilizer and be mowed gently.

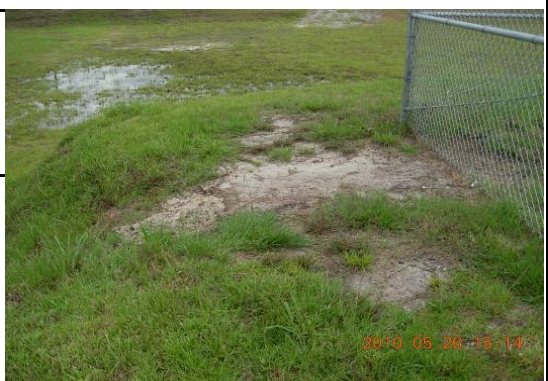
3919	This bare spot is due to erosion from concentrated rainfall runoff. The fix would be to <b>install an earth berm and plastic pipe down drain</b> buried in the slope.

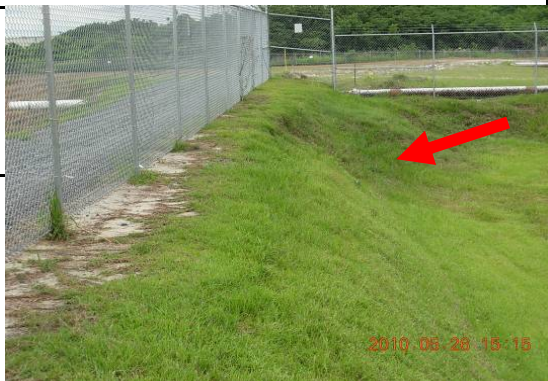
3920	This slope is too steep to maintain and is also a risk for a slide. <b>This area needs to be filled in to a slope matching that of the surrounding slopes</b> (roughly 2:1).

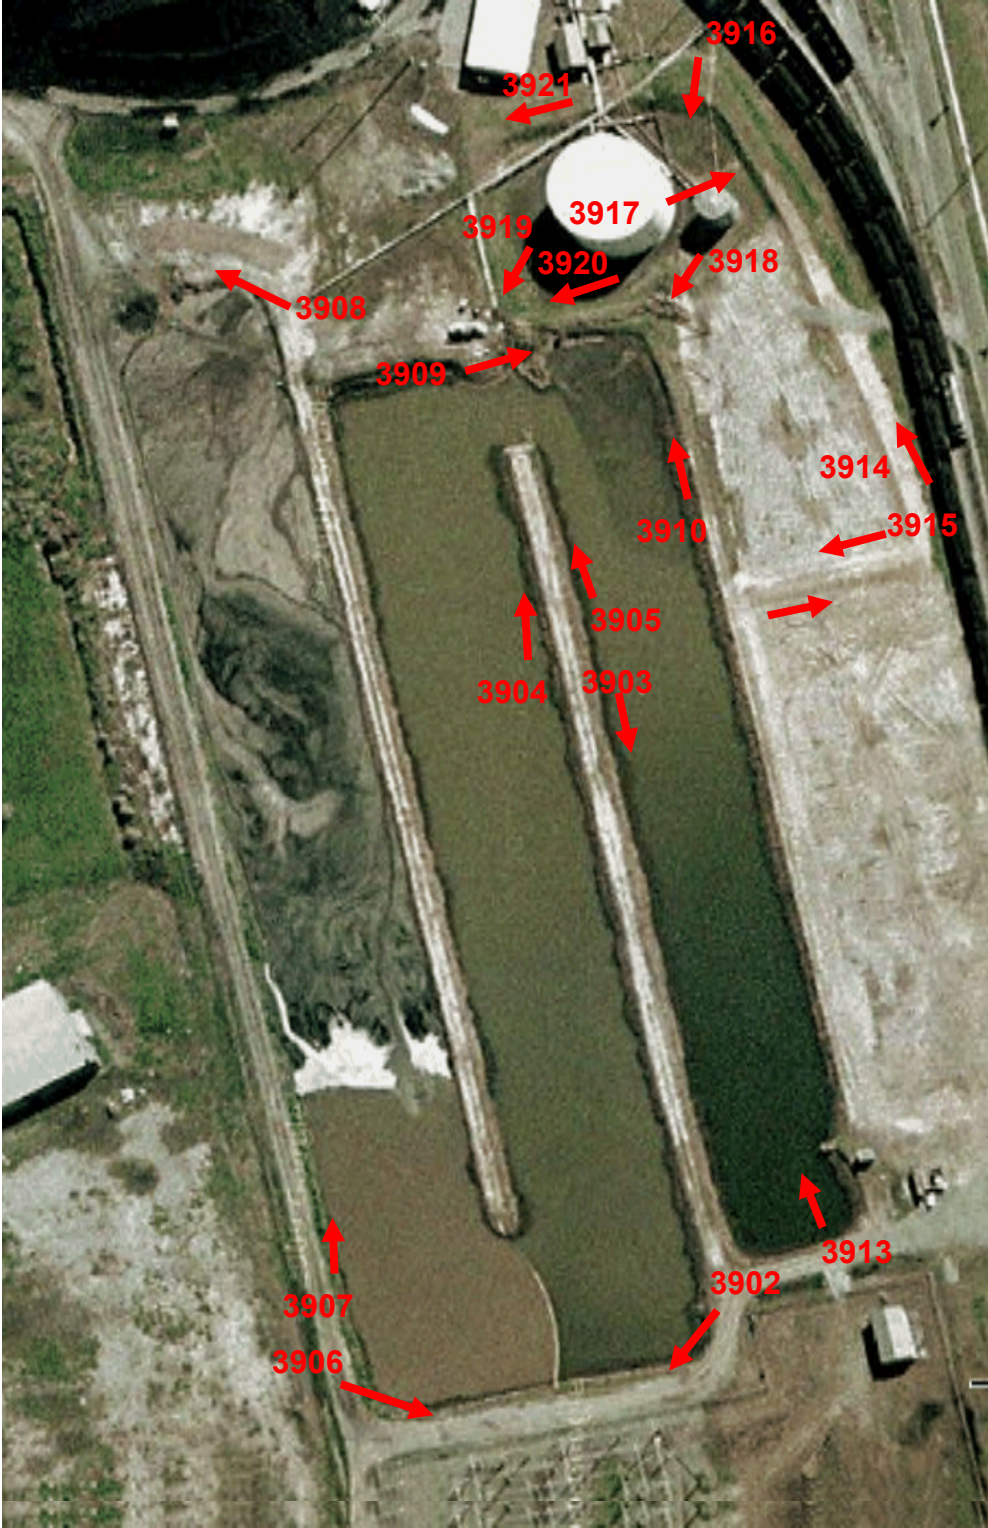
<div> <div>Plant Kraft</div> <div>Oil Containment Dike Inspection Photographs - May 26, 2010</div> <div>(See accompanying report attached)</div> </div>		
Photo No.	Description	Photo
3921	The dike in this location shows bare spots, some due to rutting and some due to scalping. The slope is too steep. The slope should be flattened and the area regrassed with suitable grass seed, fertilizer and mulch.
